DEPARTMENT OF THE INTERIOR
UNITED STATES GEOLOGICAL SURVEY

THE
SAN FRANCISCO EARTHQUAKE AND FIRE

APRIL 18, 1906

AND THEIR EFFECTS ON STRUCTURES AND
STRUCTURAL MATERIALS

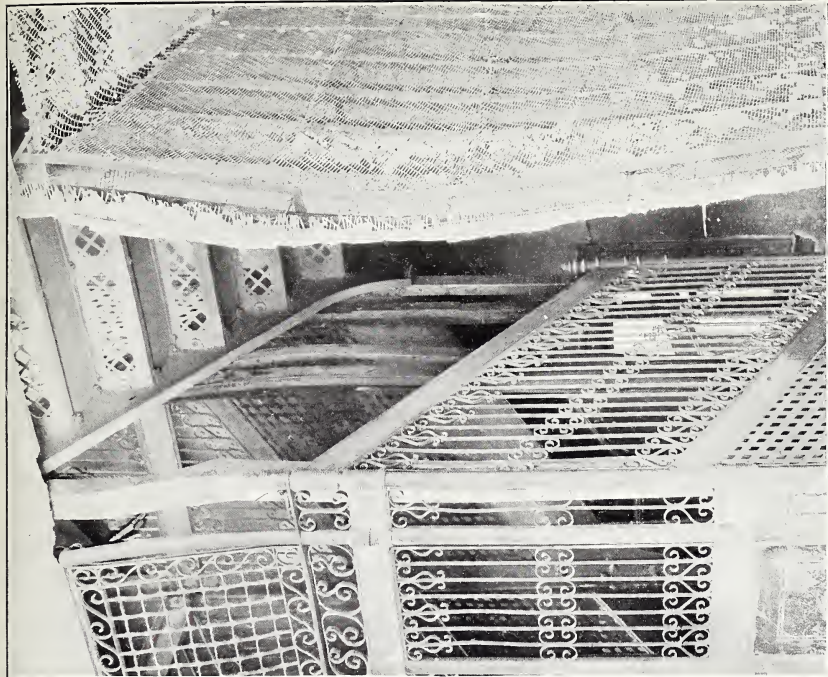
B. WARPING OF PLASTERED METAL-LATH COVERING BY FIRE, MURPHY BUILDING, SAN FRANCISCO.
 Photograph by Richard L. Humphrey.

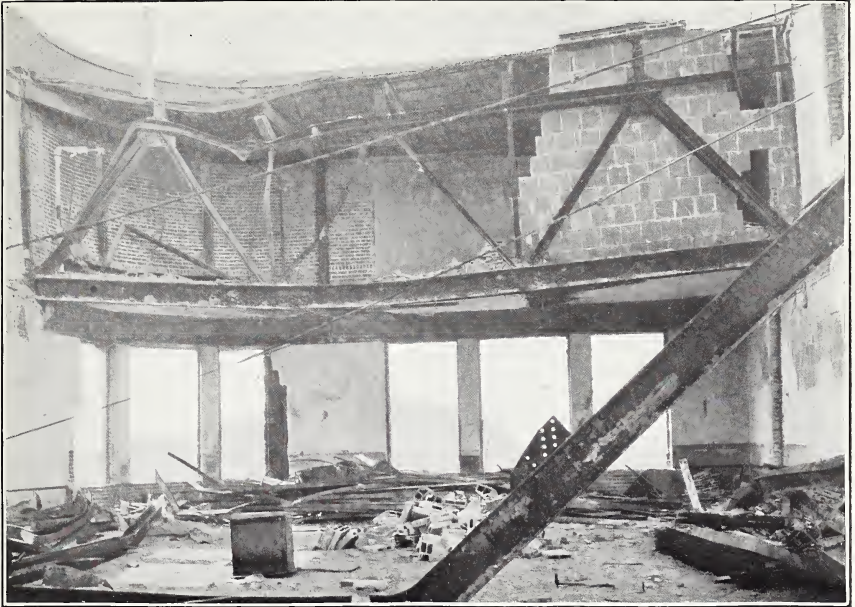
A. ROOF TRUSSES DAMAGED BY HEAT, THROUGH FAILURE OF TERRA-COTTA COVERING, MUTUAL LIFE BUILDING, SAN FRANCISCO.

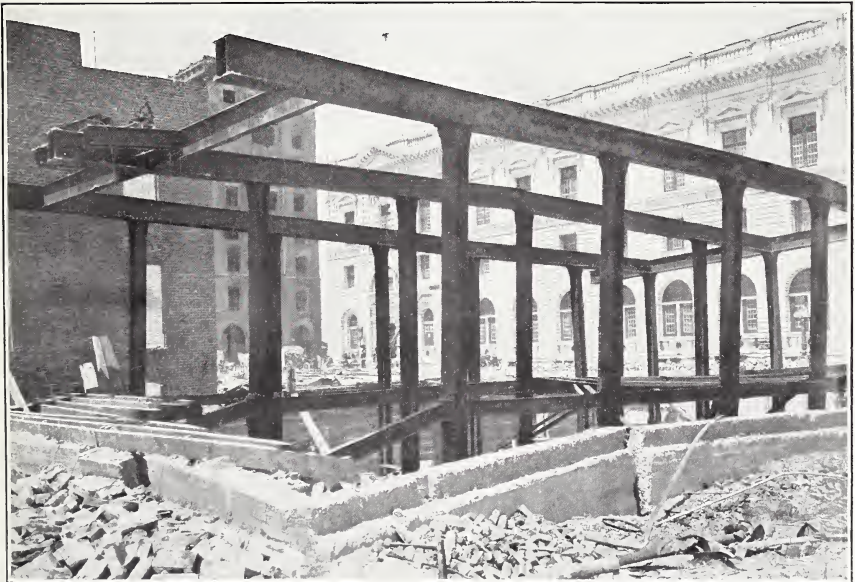
B. EFFECT OF SETTLING OF GROUND SUBJECTED TO EARTHQUAKE VIBRATIONS, STEEL-FRAME BUILDING UNDER CONSTRUCTION.

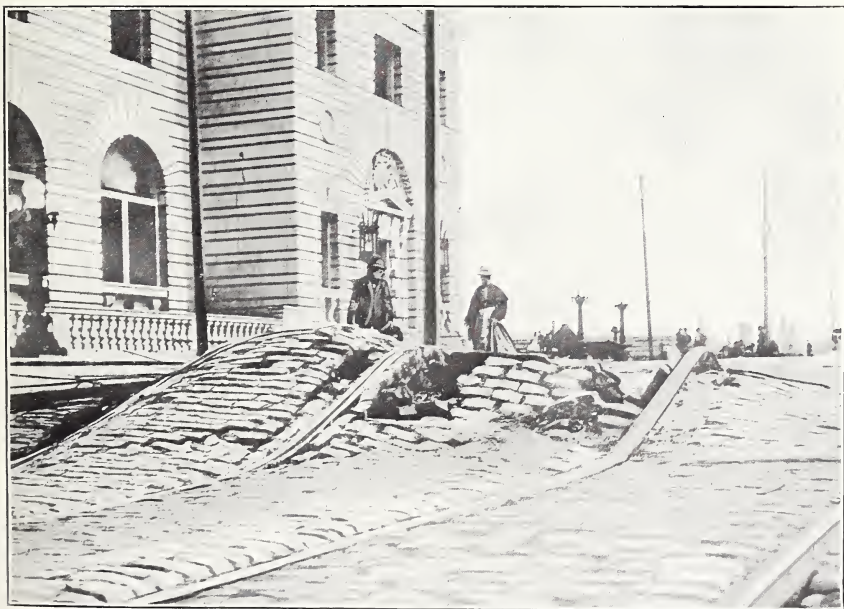
B. EFFECT OF SLIP, MISSION STREET, SAN FRANCISCO.

Corner of post-office building at the left. Photograph submitted by Richard L. Humphrey.

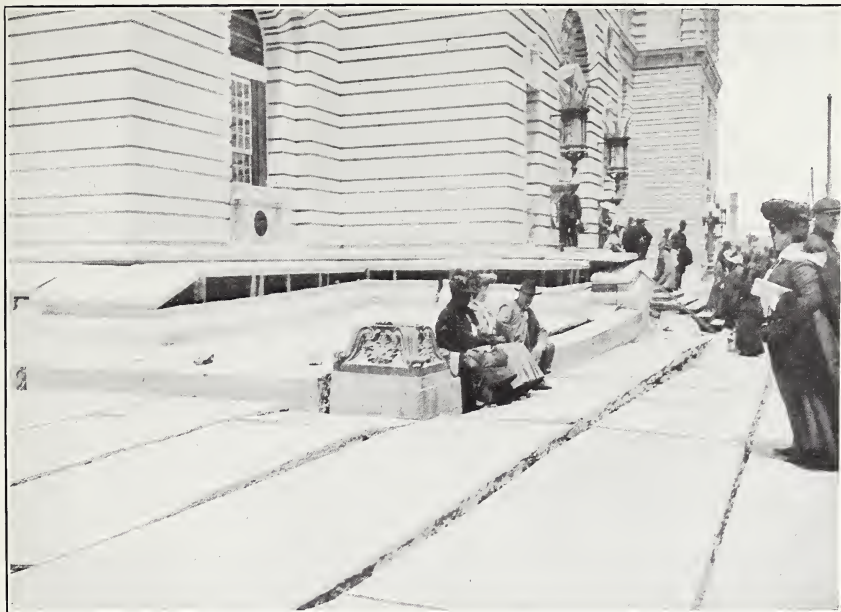
A. CRACKS IN MASONRY AND SETTLING OF OUTER TERRACE, POST-OFFICE BUILDING, SAN FRANCISCO.

The surface of the street went down at this point at least 4 feet. Photograph by John Stephen Sewell.

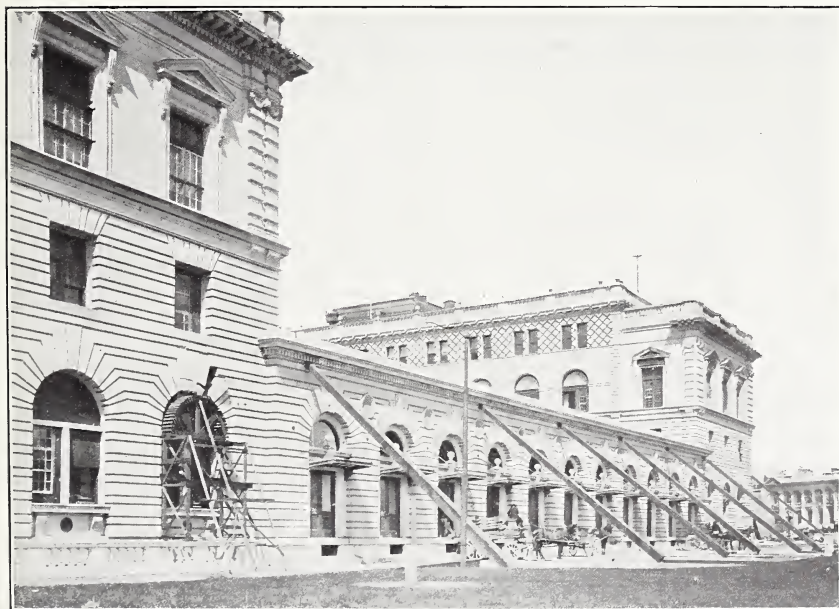
B. EFFECT OF EARTHQUAKE IN LOOSENING STONEMWORK, NORTHEAST FACE OF POST-OFFICE BUILDING.

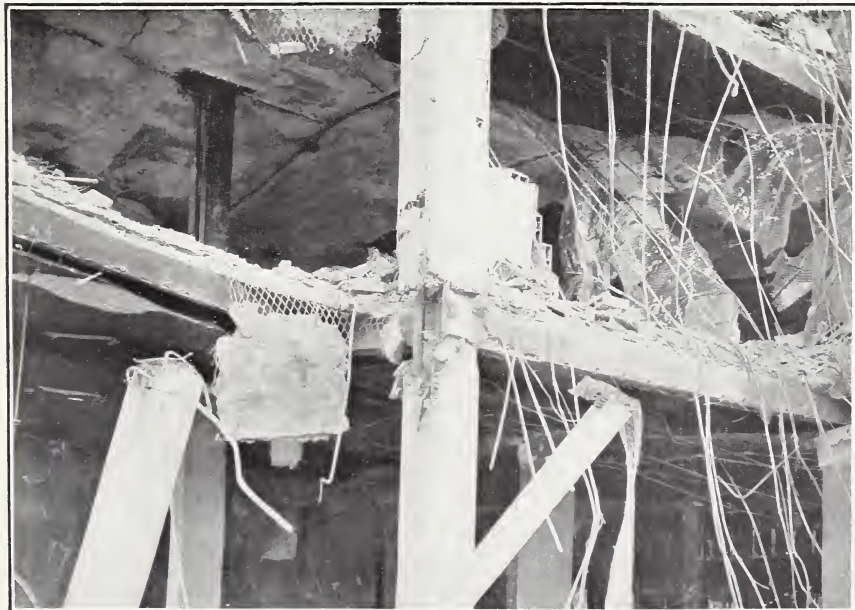
B. DAMAGE SAID TO HAVE BEEN CAUSED BY DYNAMITE, RIALTO BUILDING.

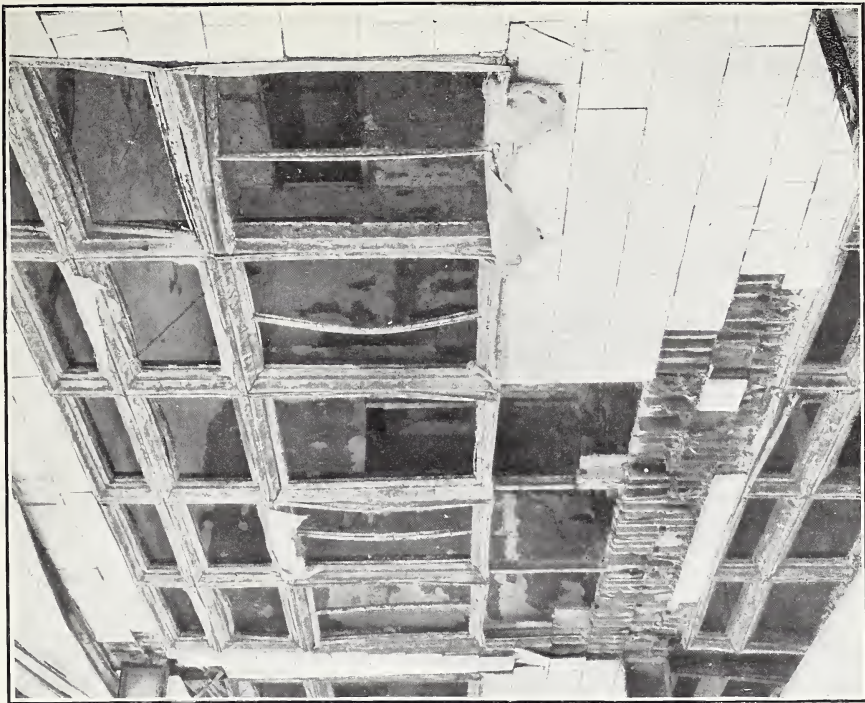
B. FAILURE OF TERRA-COTTA TILING AND METAL-FRAME WIRE-GLASS WINDOWS BY FIRE; LIGHT-WELL COLUMN, WELLS-FARGO BUILDING, SAN FRANCISCO.

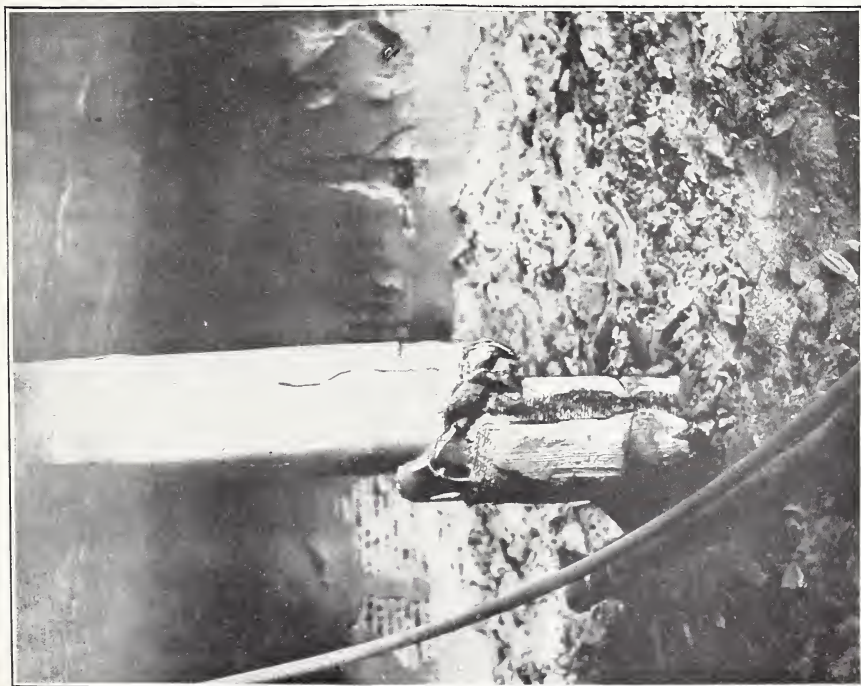
A. FAILURE OF BASEMENT COLUMN DUE TO FIRE, SLOANE BUILDING, SAN FRANCISCO.

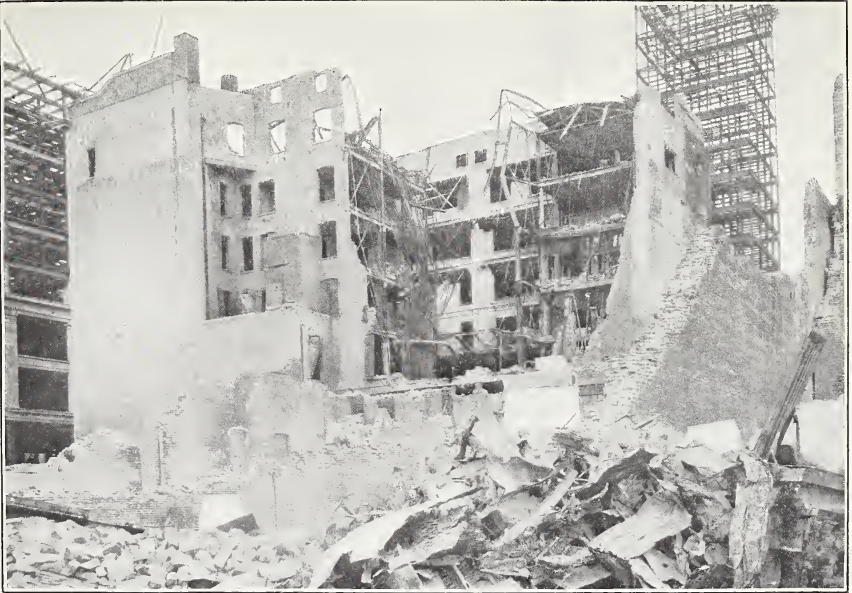
A. COLLAPSE OF BUILDING DUE TO BUCKLING OF COLUMNS, SPRING VALLEY WATER COMPANY'S BUILDING, SAN FRANCISCO.

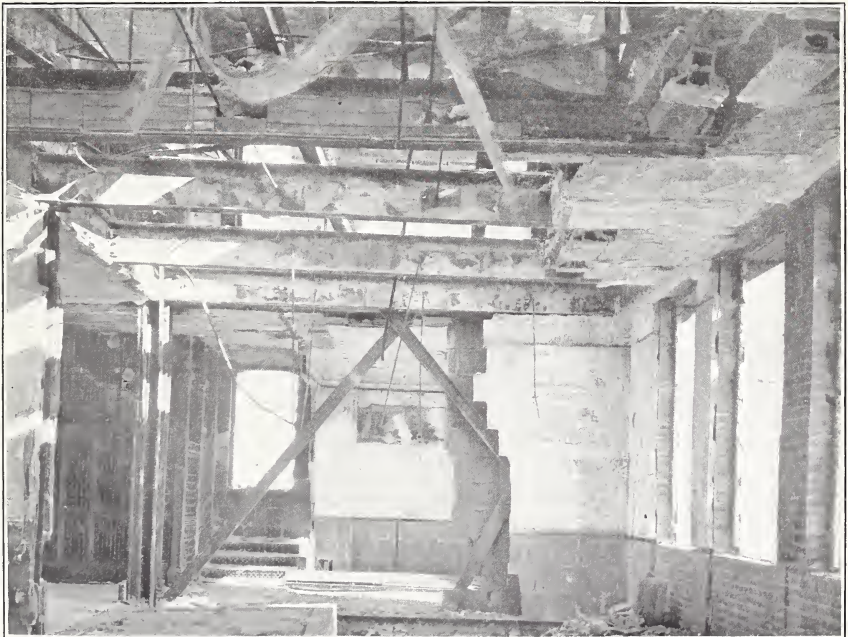
B. FAILURE OF TERRA-COTTA TILE COVERING IN FIRE, UNION TRUST COMPANY'S BUILDING, SAN FRANCISCO.

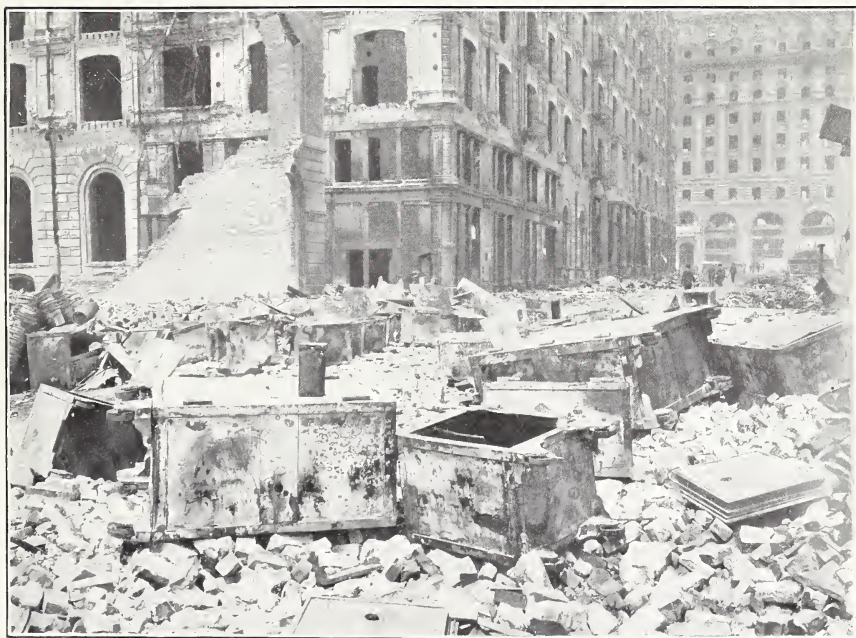
B. ABSOLUTE FAILURE OF SO-CALLED "FIREPROOF" SAFES.

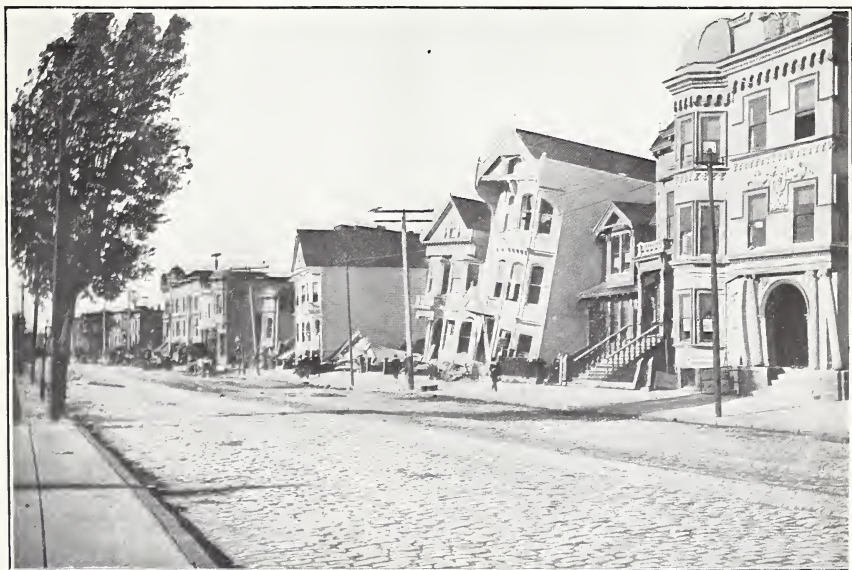
B. GENERAL EARTHQUAKE EFFECT ON FRAME BUILDINGS SITUATED ON ALLUVIAL SOIL, HOWARD STREET, SAN FRANCISCO.
